Manhole Inspection Summary

Manhole # S19E__024MH

Insp Date: **10/12/07 9:53 AM**

Location Address: **255 PAYSON-ALLEY-MONROE** Cross Street: **SARATOGA ST**

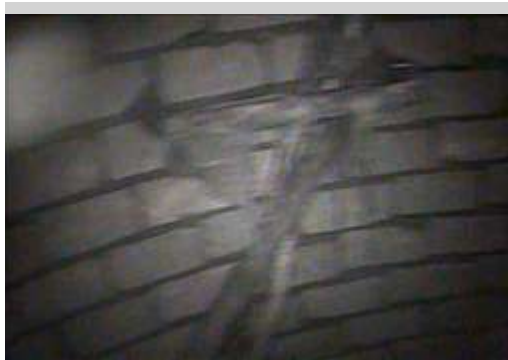
Defect 5

Surcharge ☒ **Evidence Of Surcharge** Depth: **4** (ft.) ☐ Active Surcharge Present

SURCHARGE EVIDENCE ON STEPS

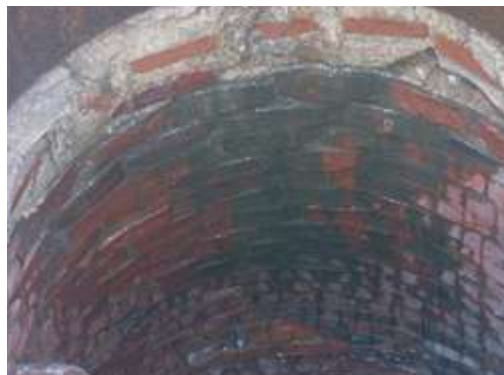
Defect 4

Chimney / Frame Adjustment ☒ Exists Material: **Brick and Concrete** ☐ Parged Height: **6** (in.)
Condition: ☐ Sound ☐ Cracked ☐ Root Intrusion ☒ **Loose Brick** ☐ Deteriorated
Infiltration: ☐ None ☐ Joint ☐ Cracks ☐ Mortar ☐ Roots ☒ **Wall**

CHIMNEY INFILTRATION

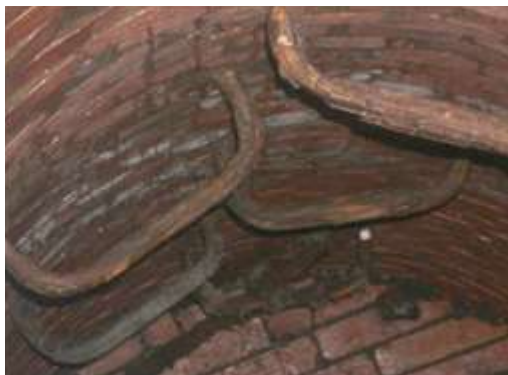
Defect 3

Steps Count: **4** Missing: **0** ☒ **Corroded**

CORRODED STEPS

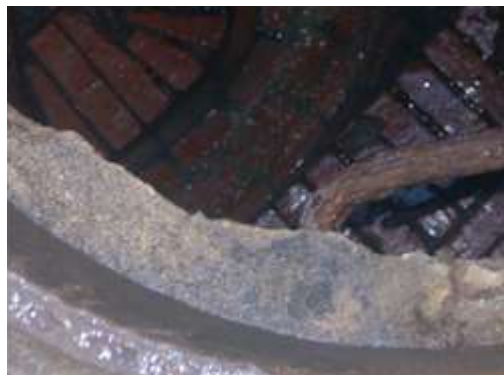
Defect 2

Frame Offset: **3** (in.) Condition: ☒ Sound ☐ Cracked ☐ Leaks

FRAME OFFSET

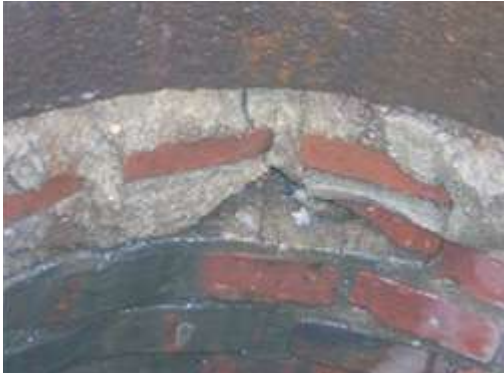
Defect 1

CRACKED CHIMNEY AND LOOSE BRICKS

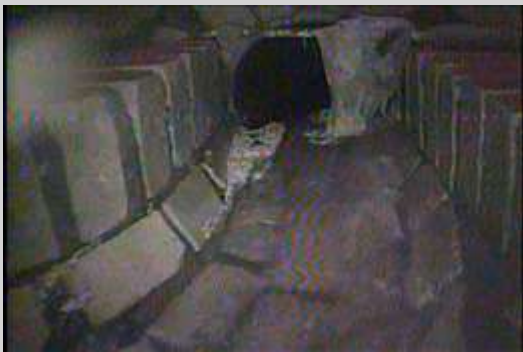
12 O'Clock Outflow

Pipe Height: **7.2** (in.) Rod and Bar (Angled)
Pipe Material: **Clay** ☐ Pipe Lined
Invert Depth: **9.34** (ft.) Flow Characteristics: **Slow**
Deposits: ☐ None ☐ Mud ☐ Sludge ☒ **Debris** ☐ Grease
Silt Depth: **2** (in.) Deposits Extent: **Light**
Infiltration: **None** Pipe Seal Cond: **Sound**

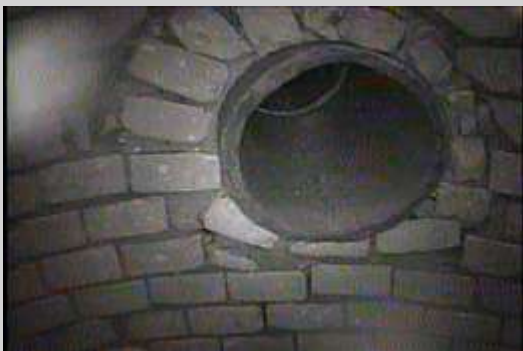
9 O'Clock Inflow

SURCHARGE EVIDENCE ON STEPS

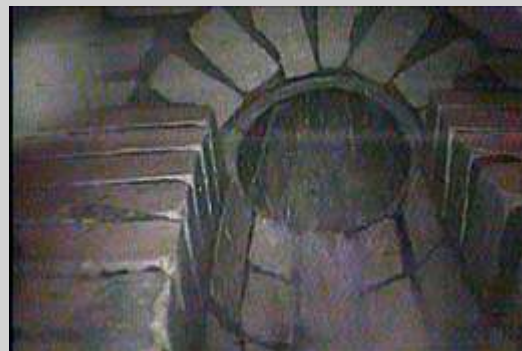
Drop In @ 9 O'Clock

SURCHARGE EVIDENCE ON STEPS
